# CASE STUDY

**Application:** Elevated Walkway

**Product:** Corvex® Square Mesh Molded Grating

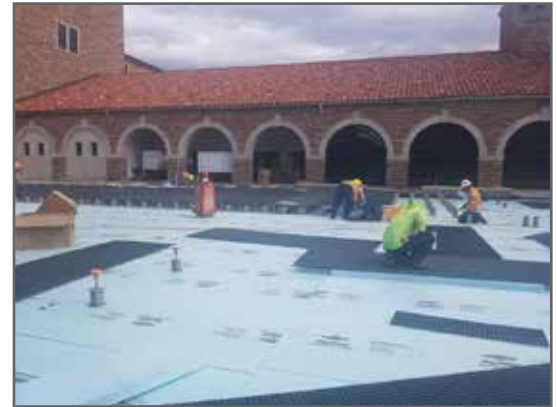
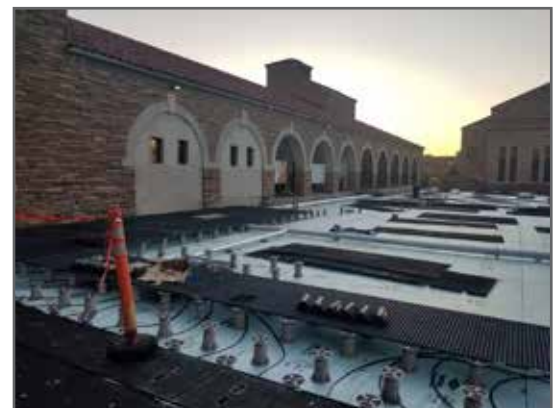
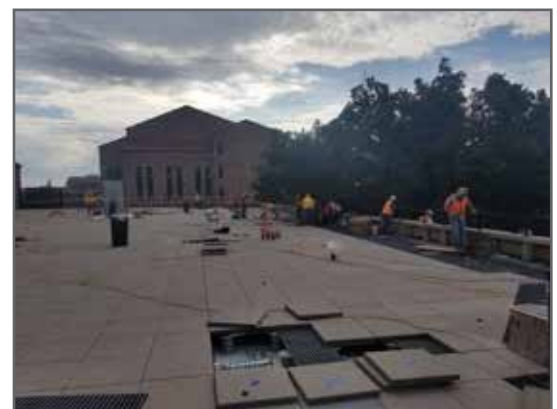
Fibergrate was able to provide the ideal solution for this university by using Corvex molded grating as the structural grating support under the concrete pavers. Corvex is an isophthalic polyester resin system used in highly corrosive environments such as industrial, chemical, and water/wastewater facilities. This resin system will help prevent these gratings from corroding due to the maintenance process they go through every time there's snow on top of them. Molded grating was the chosen material because it covers the following needs for this application:

- **Corrosion Resistance** - Molded grating is known for its corrosion resistance in the toughest environments. These gratings will be able to withstand Colorado snowy weather with ease.
- **Low Maintenance** - The corrosion resistant properties of molded grating will reduce or eliminate the need for maintenance on this application even after salt water percolates through the concrete.
- **High Strength to Weight Ratio** - Fiberglass Reinforced Plastic (FRP) is less than one-half the weight of steel grating, yet FRP is strong enough to carry the vehicular loads this application will encounter. Its lighter weight allows easy installation and easy removal if necessary.
